Section 3 Printer Troubleshooting Guide

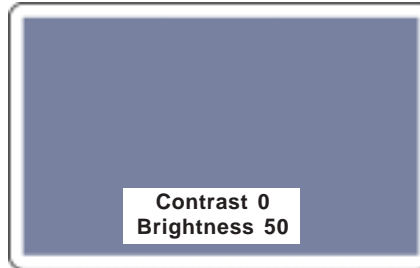
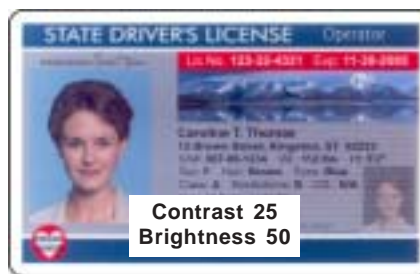
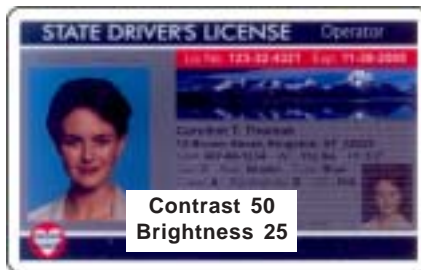
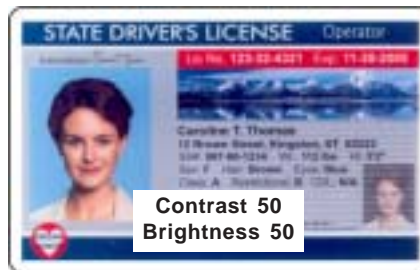
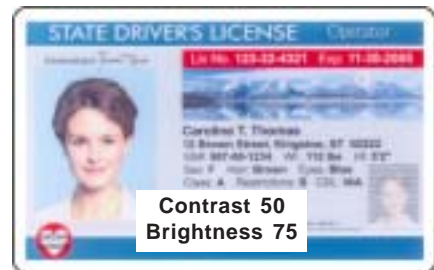
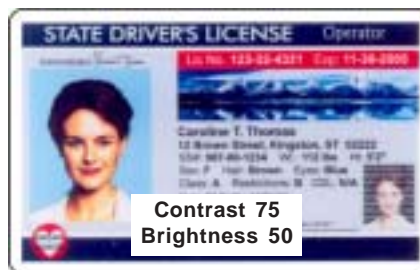
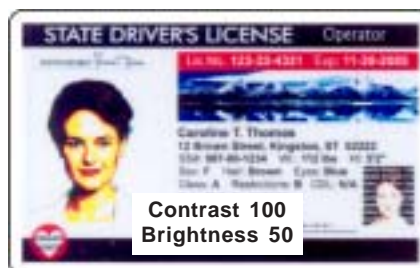
Brightness and Contrast controls on the image Adjustment screen have same effect on the printed image as do similar controls on typical office color printers. Click Reset to restore default conditions.

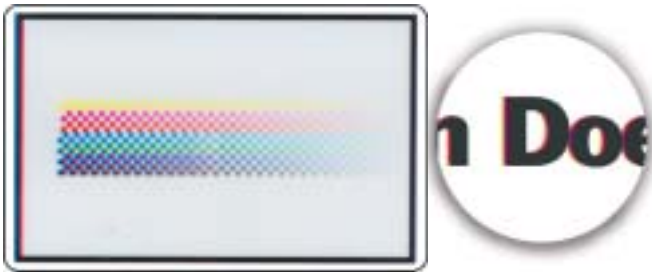
Examples of color mis-registration

Left is the test card in the printer's firmware. Right is an enlargement showing fringing on process black text generated from Y, M and C

- Minor mis-registration of Y, M and C color passes may be due to printhead angle adjust screw not in firm contact with printhead frame. *TN4*
- For gross mis-registration of Y, M and C suspect card not firmly against left hand pick edge of truck on one or more passes. Spring at left end of platen may be missing or bound up. *TN2*
- Check printed card for damage on corners or edges. Example: the card may be scraping along the underside of the hopper base molding. *TN2*
- Printhead pressure too light. *TN4*
- Printhead may be running hot. Will occur if head resistance incorrectly entered in driver software. *TN4*
- Toothed transport belt pulley may be slipping on drive shaft. Tighten set screws (make sure the screws bear on flats on the shafts).

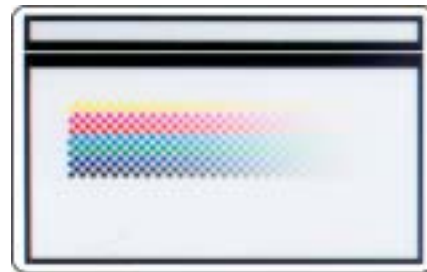
Examples of printhead failures

The white line is a sign of a blown pixel. The adjacent black stripe is a printhead driver problem (components on the head itself). These are independent problems, not necessarily co-located.

- White stripe means blown pixel (non-functioning heating element). One or two blown pixels in isolation may be acceptable to some. Otherwise replace printhead. *TN4*
- Black stripe means non-functioning circuit(s) on printhead. If so, replace printhead, *TN4*, but first check that it is not the result of an image size change not followed by power cycling the printer.

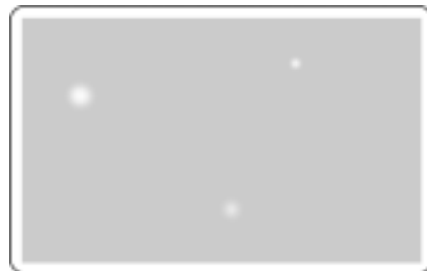
Possible card defects

White spots like these may be caused by card surface imperfections.

- Possible card quality problem. Run IDPrint Lite with [graytone.bmp](#) on cards from a different batch. Check platen surface for specks of debris.

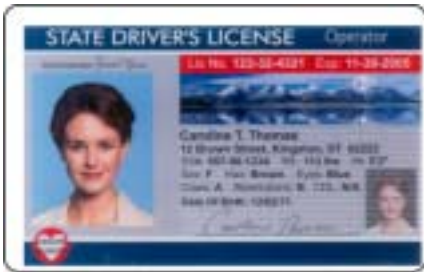
Image offset on card

Correct this by increasing horizontal (X) offset, decreasing vertical (Y) offset.

- Properties > Device Settings > Printer Adjustment > Horizontal/Vertical Offset.

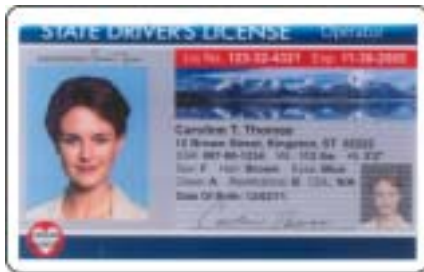
Image loss at top of card

Could be on either edge. Almost certainly due to ribbon fold-over, but could be a head non-pivoting problem, or an image size problem.

- Ribbon folded over at edge. Slacken ribbon by pulling more out of supply roll, unfold edge then press RIBBON button to re-sync. *TN4*
- Bottom edge and/or right hand edge of image missing could be card layout application sending wrong image size (should be 952 x 578 pixels). Select appropriate image size (if available) in Preferences, or modify layout application.

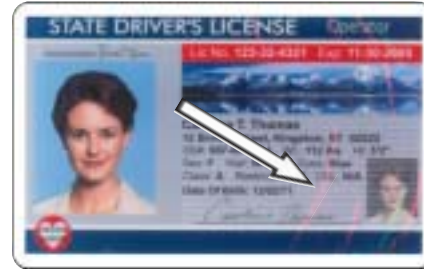
Random colored lines

Probably resulting from excessive takeup torque.

- Ribbon wrinkling. Reduce takeup torque. Check print-head pressure. *TN4*
- Too much heat being applied to YMC panels. Try reducing gain, offset and preheat separately for each color in the driver Device Settings > Color Calibration, *TN4-5*. Typically, the set of values should be the same for each color.
- Printhead running too hot. Can happen after head replacement if head resistance incorrectly entered through printer driver. *TN4, Printer Adjustment*
